# **Trombe Walls in Low-Energy Buildings: Practical Experiences**

**Preprint**

P. Torcellini and S. Pless

*To be presented at the World Renewable Energy Congress VIII and Expo  
Denver, Colorado  
August 29–September 3, 2004*

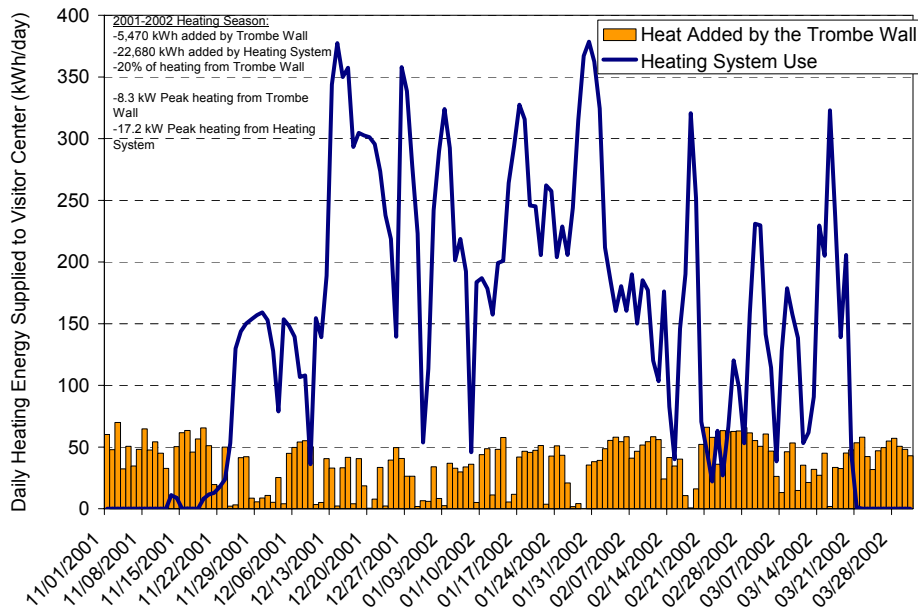
**Figure 4. Zion Visitor Center Trombe wall and heating system performance, 2001-2002 heating season**

The temperature gradient in the wall was measured during the 2001-2002 heating season. With internal temperature measurements, the Trombe wall energy supplied to the building was calculated based on published heat flux calculation methods (Balcomb 1980). The Visitor Center Trombe wall daily performance during the 2001-2002 heating season is shown in Figure 4. The electric radiant heating system used 22,680 kWh (81.6 GJ) over the year, with the Trombe wall contributing 20% of the total heating to the building. The Trombe wall imposed a heating load on the building for only two of the 151 days of the 2001-2002 heating season. For the other 149 heating days, the wall was a net positive. The peak heat flux through the wall was 11.2 W/ft<sup>2</sup> (89 W/m<sup>2</sup>), or 8.3 kW over the entire Trombe wall area. The average efficiency of the wall (defined as the heat delivered to the building divided by the total solar radiation incident on the exterior of the wall) was 13%.
